**Flood Control Project Maintenance
Levee Inspections**

Maintenance Issue Types Only, Levee Inspection Report By Mile - Spring 2019

Reclamation District No. 0536 Egbert

Waterway	Bank	Unit Miles	Inspection Start/End	Inspector
Unit No. 01 Lindsey Slough	Right	5.58	04/11/2019 04/11/2019	David Julian

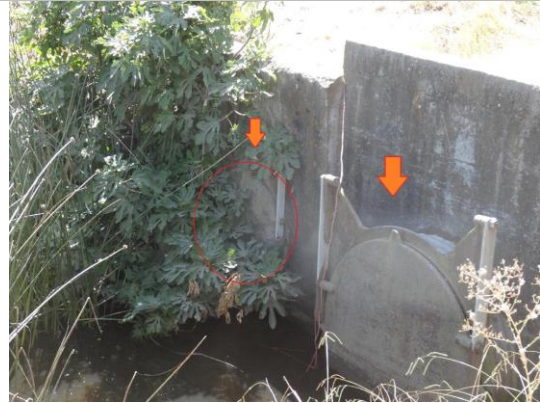
Photo 1 of 3 : UCIP_SP_2019_53359_34457.jpg

Comment Code						
Inspector Comment						
FS_ID:53359 DS_ID:22712 EP_NO: 10114 Repair Type: Urgent Crossing Status: Found UCIP Comments: 10/2/2018 Holes present in pipe pose internal levee threat; keeping as Urgent (D. Sanoski - DWR UCIP).06/01/2016: Holes and heavy corrosion inside pipe on WS have gotten worse. Flapgates appear in good condition though vegetation blocks view of flapgate for 36-inch on WS. These pipes are still in use and necessary for drainage; pipes may be eligible for repair under DWR Deferred Maintenance Program. (K. Fazel - UCIP)08/13/2013:- Holes in pipe outlet due to heavy corrosion.- Needs detailed investigation of the pipe.- Headwall cracked and tilted on WS. (P. Amatya - DWR) FIELD_STRUCT_DESC: 1 of 2: 60-inch corrugated metal gravity drainage pipe through the levee, 10 feet below the crown. Flap gate on the waterside (WS). Headwall on each end. Culverts run under the road to provide drainage from agricultural fields via a landside (LS) ditch to Lindsey Slough. No. 100 gate in the LS drainage ditch. Reclamation District No. 536 (RD0536) president is David Hearn at hearnd5@gmail.com. (Retention of one 60-inch and one 36-inch drainage pipes through the levee, 10 feet and 6.5 feet below the crown, respectively, and flap gates on the WS ends authorized under Automatic Board Order (ABO) issued as Permit No. 10114, 1974 - H. E. Peterson). [Additional Reference(s): DWR Levee Log, 1992. USACE Sacramento O&M Manual 106, May 1953, (Station 294+49 ""A""), invert elevation 14.4 feet]. FS Date: 10/2/2018 1:53:00 PM

WS view: two CMPs with flap gates. Concrete headwall supports the pipes. A 36" CMP (left) and 60" CMP (right).

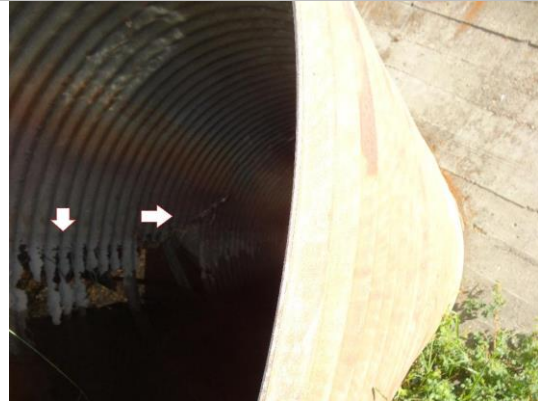
Photo 3 of 3 : UCIP_SP_2019_53359_34455.jpg

Comment Code						
Inspector Comment						
FS_ID:53359 DS_ID:22712 EP_NO: 10114 Repair Type: Urgent Crossing Status: Found UCIP Comments: 10/2/2018 Holes present in pipe pose internal levee threat; keeping as Urgent (D. Sanoski - DWR UCIP).06/01/2016: Holes and heavy corrosion inside pipe on WS have gotten worse. Flapgates appear in good condition though vegetation blocks view of flapgate for 36-inch on WS. These pipes are still in use and necessary for drainage; pipes may be eligible for repair under DWR Deferred Maintenance Program. (K. Fazel - UCIP)08/13/2013:- Holes in pipe outlet due to heavy corrosion.- Needs detailed investigation of the pipe.- Headwall cracked and tilted on WS. (P. Amatya - DWR) FIELD_STRUCT_DESC: 1 of 2: 60-inch corrugated metal gravity drainage pipe through the levee, 10 feet below the crown. Flap gate on the waterside (WS). Headwall on each end. Culverts run under the road to provide drainage from agricultural fields via a landside (LS) ditch to Lindsey Slough. No. 100 gate in the LS drainage ditch. Reclamation District No. 536 (RD0536) president is David Hearn at hearnd5@gmail.com. (Retention of one 60-inch and one 36-inch drainage pipes through the levee, 10 feet and 6.5 feet below the crown, respectively, and flap gates on the WS ends authorized under Automatic Board Order (ABO) issued as Permit No. 10114, 1974 - H. E. Peterson). [Additional Reference(s): DWR Levee Log, 1992. USACE Sacramento O&M Manual 106, May 1953, (Station 294+49 ""A""), invert elevation 14.4 feet]. FS Date: 10/2/2018 1:53:00 PM

LS view: holes & cracks on CM pipe due to heavy corrosion. Needs detailed investigation of the pipe.

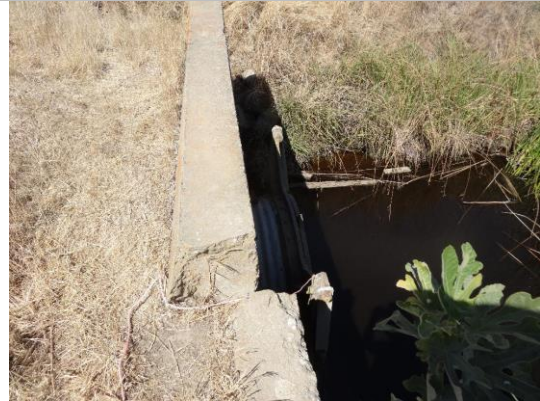
Photo 2 of 3 : UCIP_SP_2019_53360_34770.jpg

WS view: cracked and tilted concrete headwall.

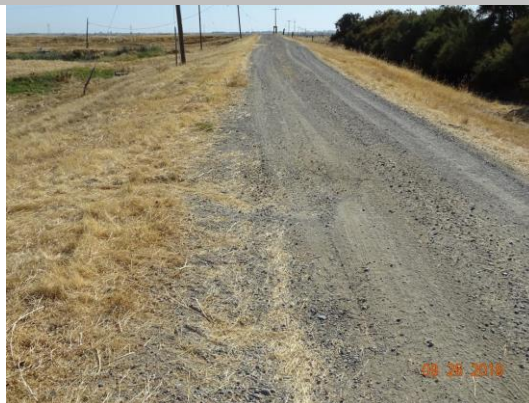
Photo 1 of 2 : SP_2019_RD0536_208_21_20190311_00010.jpg

LM Start	0.28	Rating **	M	Issue No.	21
LM End	0.28	Issue Type +	Ma	Location *	CR
Category	Earthen Levee			GPS Latitude/Longitude	
				Start	End
Item	Crown Surface / Depressions / Rutting			38.245607 °	38.245607 °
				-121.763993 °	-121.763993 °
DWR ID	DWR_RD0536_01_s_2017_21				
Comment Code					
C2 : Repair depressions or ruts in the crown or slope.					
Inspector Comment					
Crown rutting has been reduced by regrading and addition of base rock in RD536, but large depression exists. Should be repaired.

Depression in the road. It has been graded but some depressions still exist (September 2018).

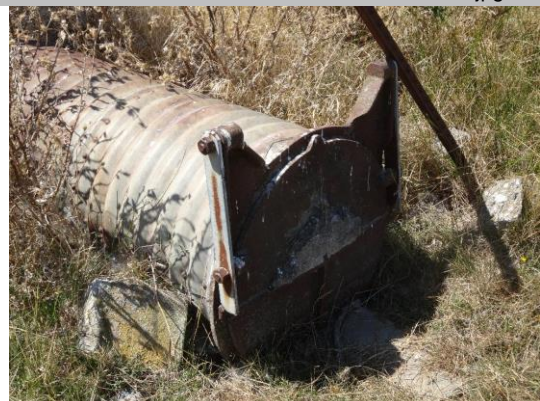
Photo 2 of 3 : UCIP_SP_2019_49313_34773.jpg

WS view: CM pipe blocked by concrete debris on levee slope.

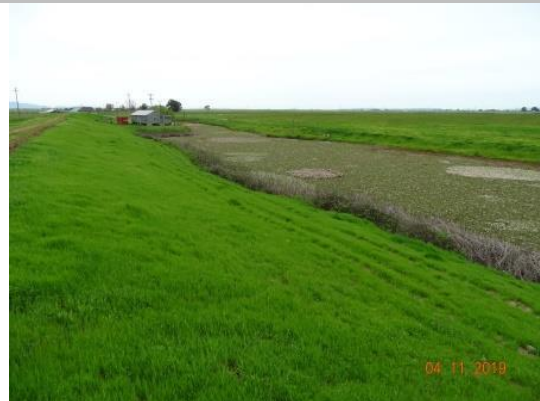
Photo 1 of 2 : SP_2019_RD0536_208_14_20190412_00055.jpg

LM Start	0.67	Rating **	M	Issue No.	14
LM End	0.98	Issue Type +	Ma	Location *	WS
Category	Supplemental			GPS Latitude/Longitude	
				Start	End
Item	2017 USACE Erosion Survey, DRAFT			38.249615 °	38.253717 °
				-121.760165 °	-121.757979 °
DWR ID	DWR_RD0536_01_f_2018_14				
Comment Code					
Inspector Comment					
2017 Site ID: LDS 0.6 R					
Status: Eroding					
2017 Field Notes: Appears to be cow paths along slope causing erosion.					
Site History: 2011 - Multiple sections of slumping bank. 2016 - Bank continues to erode.					
2019 Field Notes: Riprap placed in at least 1 large erosion spot

View looking upstream at cow ruts on the waterside slope (Spring 2019).

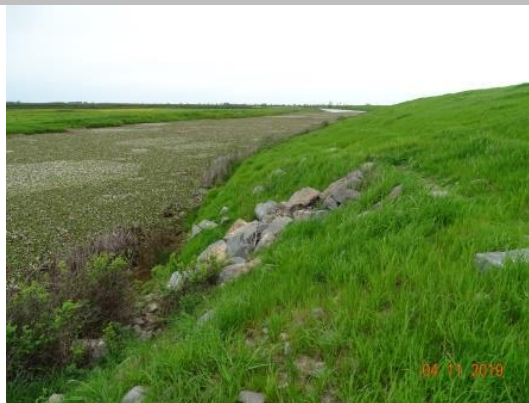
Photo 2 of 2 : SP_2019_RD0536_208_14_20190412_00056.jpg

View looking downstream at erosion spot with rock placed on it (Spring 2019).

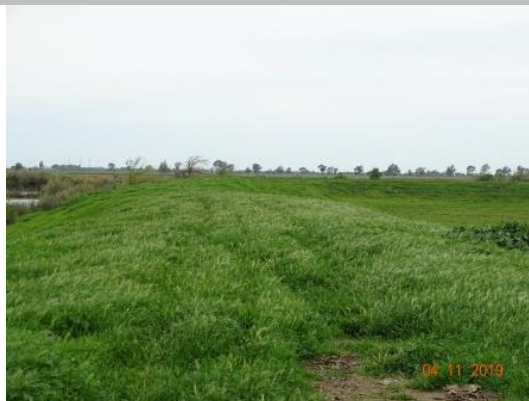
Photo 1 of 1 : SP_2019_RD0536_208_31_20190412_00057.jpg

LM Start	0.74	Rating **	M	Issue No.	31
LM End	1.80	Issue Type +	Ma	Location *	CR
Category	Earthen Levee			GPS Latitude/Longitude	
				Start	End
Item	Vegetation			38.250513 °	38.259690 °
				-121.759383 °	-121.749481 °
DWR ID	DWR_RD0536_01_s_2019_31				
Comment Code					
V9 : Keep the crown roadway free of vegetation.					
Inspector Comment					
Remove annual vegetation from the crown road.

View looking downstream at vegetation on the crown (Spring 2019).

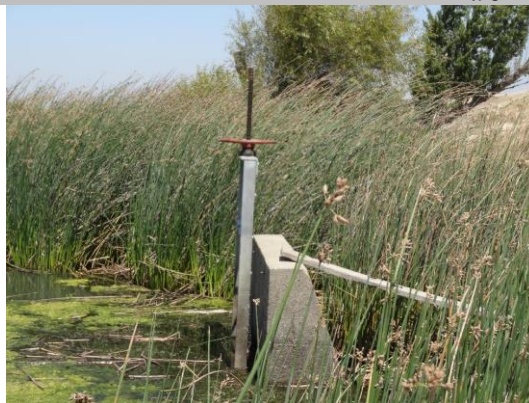
Photo 1 of 2 : UCIP_SP_2019_20444_34493.jpg

Comment Code						
Inspector Comment						
FS_ID:20444 DS_ID:22715 EP_NO: 10115 Repair Type: No Action Needed Crossing Status: Found UCIP Comments: Pipe was submerged into water and not visible.Steel bar fence on both sides of the levee. FIELD_STRUCT_DESC: 42-inch corrugated metal gravity drainage pipe through the levee, 22.5 feet below the crown. Concrete headwall on each end. Screw gate on the waterside (WS) end. (Retention of a 42-inch drainage pipe through the levee, 22.5 feet below the crown, and a slide gate on the WS end authorized under Automatic Board Order (ABO) issued as Permit No. 10115, 1974 - Petersen Estate Company, care of R. Moss). [Additional Reference(s): DWR Levee Log, 1992. USACE Sacramento O&M Manual 106, May 1953, (Station 238+36 ""A""), invert elevation 1.5 feet]. FS Date: 8/13/2013

WS view: slide gate, concrete headwall in the channel. Pipe submerged into water.

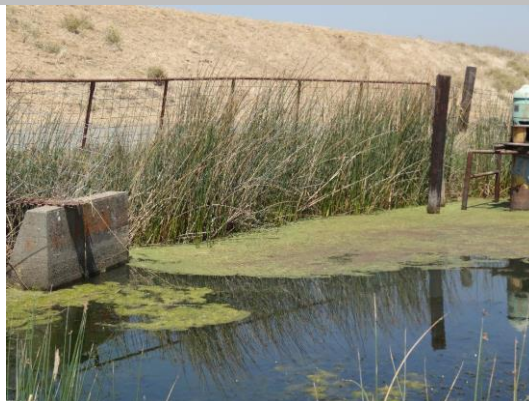
Photo 2 of 2 : UCIP_SP_2019_20444_34492.jpg

LS view: concrete headwall in the channel/irrigation ditch. Pipe submerged into water.

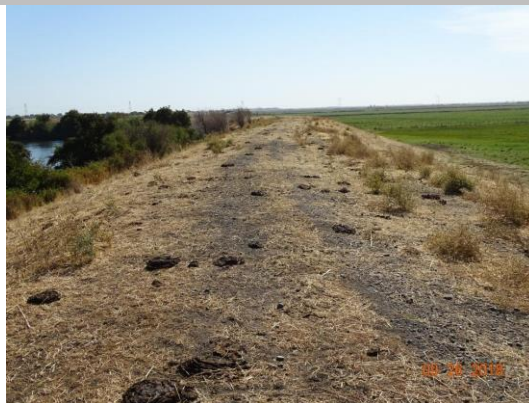
Photo 1 of 1 : SP_2019_RD0536_208_47_20190311_00019.jpg

LM Start	1.14	Rating **	M	Issue No.	47
LM End	1.55	Issue Type +	Ma	Location *	CR
Category	Earthen Levee			GPS Latitude/Longitude	
				Start	End
Item	Crown Surface / Depressions / Rutting			38.256050 °	38.258637 °
				-121.757582 °	-121.753397 °
DWR ID	DWR_RD0536_01_f_2014_47				
Comment Code					
C2 : Repair depressions or ruts in the crown or slope.					
Inspector Comment					
Add appropriate gravel to the crown roadway.

View looking downstream of the crown. Gravel should be added to the roadway (September 2018).

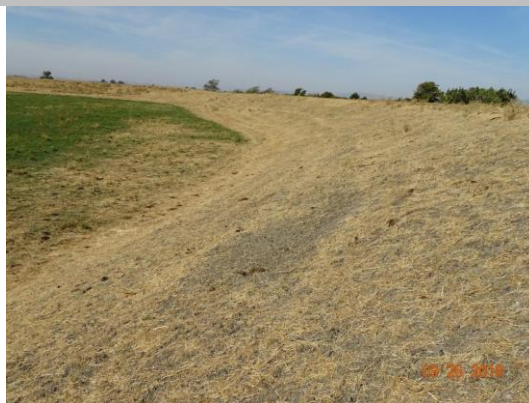
Photo 1 of 2 : SP_2019_RD0536_208_17_20190311_00005.jpg

LM Start	1.45	Rating **	M	Issue No.	17
LM End	1.45	Issue Type +	Ma	Location *	LS
Category	Earthen Levee			GPS Latitude/Longitude	
				Start	End
Item	Slope Stability			38.259087 °	38.259087 °
				-121.755133 °	-121.755133 °
DWR ID	DWR_RD0536_01_f_2018_17				
Comment Code					
S2 : Repair the levee slope damaged by foot traffic and prevent access where possible.					
Inspector Comment					
Depressions in levee due to cows should be repaired to prevent deeper depressions into levee.

View looking upstream at divots in the slope created by cows. Divots are deep enough that they should be corrected (September 2018).

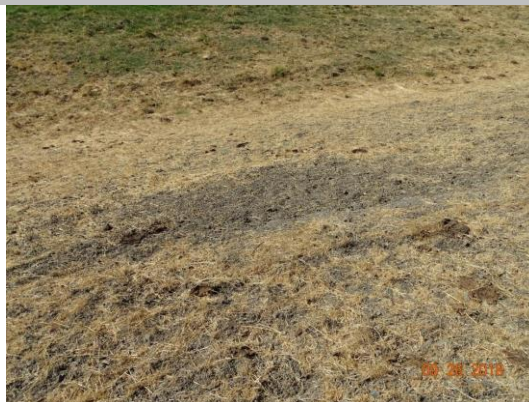
Photo 2 of 2 : SP_2019_RD0536_208_17_20190311_00006.jpg

Looking down slope at one of the cow divots (September 2018).

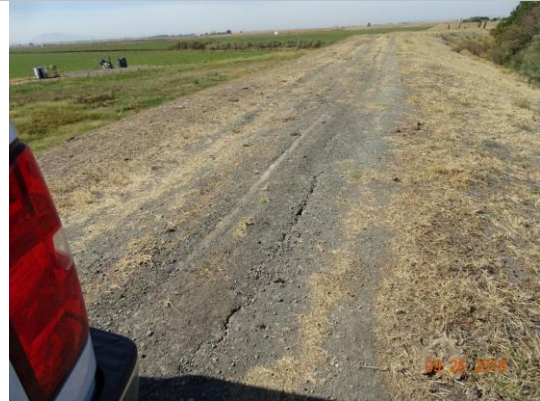
Photo 1 of 1 : SP_2019_RD0536_208_22_20190311_00012.jpg

View looking upstream at the crown. Surface cracks should be fixed and gravel added to roadway (September 2018).

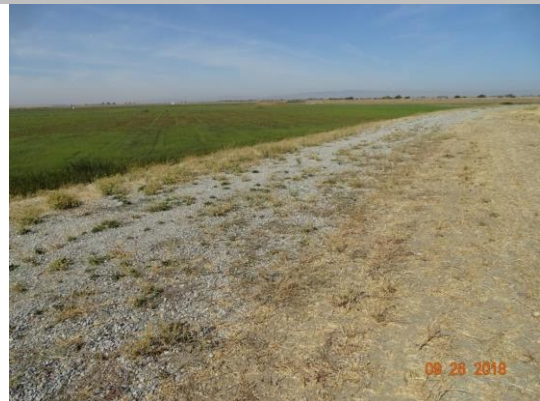
Photo 1 of 2 : SP_2019_RD0536_208_56_20190311_00020.jpg

LM Start	2.69	Rating **	A/W	Issue No.	56
LM End	2.71	Issue Type +	Ma	Location *	CR
Category	Earthen Levee			GPS Latitude/Longitude	
				Start	End
Item	Crown Surface / Depressions / Rutting			38.255197 °	38.254973 °
				-121.737932 °	-121.737577 °
DWR ID	DWR_RD0536_01_f_2014_56				
Comment Code					
C2 : Repair depressions or ruts in the crown or slope.					
Inspector Comment					
Possible subsidence in this area has been repaired. Grade was restored and base rock was added to crown. Area looks good on 3/29/18. Should continue to monitor this site for possible future subsidence.					
9/26/2018: Very minor subsidence present. Should be monitored.

View looking upstream at minor subsidence. (September 2018).

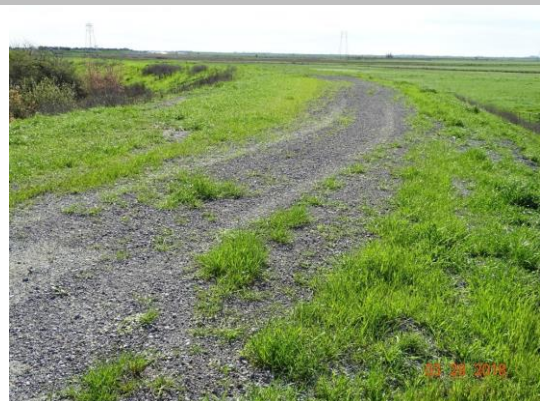
Photo 2 of 2 : SP_2019_RD0536_208_56_20190311_00021.jpg

3/29/2018: view of crown rutting and possible subsidence that has been repaired.

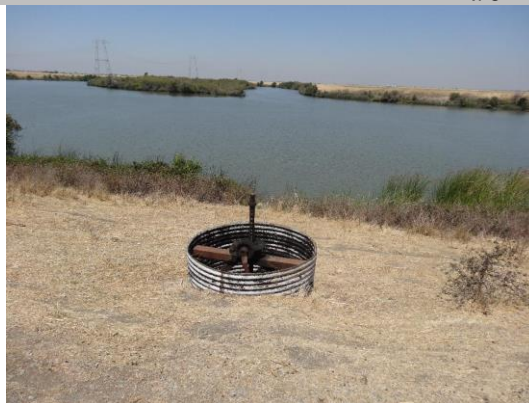
Photo 1 of 3 : UCIP_SP_2019_20503_34568.jpg

Comment Code						
Inspector Comment						
FS_ID:20503 DS_ID:22718 EP_NO: 10116 Repair Type: No Action Needed Crossing Status: Found UCIP Comments: Vortex seen on WS. Water flow seen on LS.Saddle, apron, and headwall not visible. Inlet and outlet pipe-ends are submerged into water. FIELD_STRUCT_DESC: 54-inch corrugated metal gravity drainage pipe through the levee, 30 feet below the crown. Screw gate in a pipe riser on the waterside (WS) slope. Saddle, apron, headwall, two corrugated metal cutoff walls, one No. 101 gate, and one No. 102 gate. (Retention of a 54-inch drainage pipe through the levee, 30 feet below the crown, and a slide gate on the WS slope authorized under Automatic Board Order (ABO) 10116, 1974 - Marion Sanchez Farms). [Additional Reference(s): DWR Levee Log, 1992. USACE Sacramento O&M Manual 106, May 1953, (Station 87+70 ""R""), invert elevation -2 feet]. FS Date: 8/13/2013

WS view: CMP riser with slide gate on levee slope. Water channel on background.

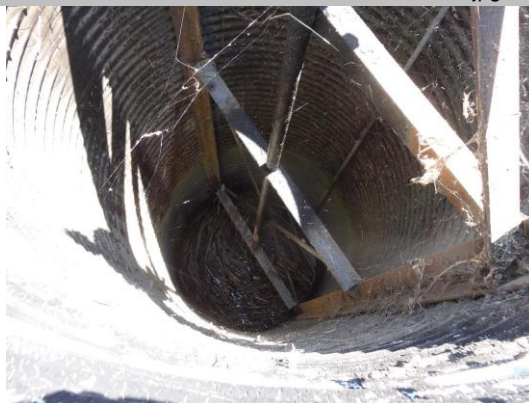
Photo 2 of 3 : UCIP_SP_2019_20503_34567.jpg

WS view: closer view of slide gate in CMP riser on levee slope.

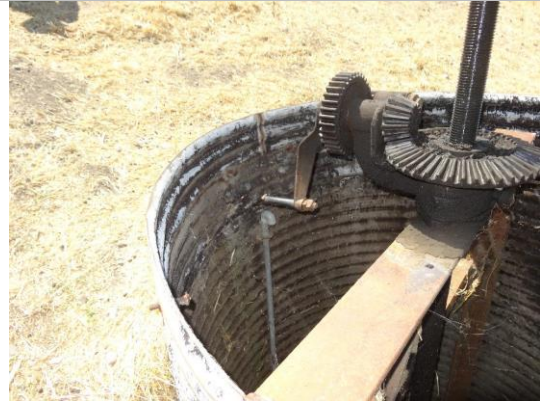
Photo 3 of 3 : UCIP_SP_2019_20503_34566.jpg

WS view: closer view of slide gate in CMP riser on levee slope. Air vent attached to the wall of CMP (left).

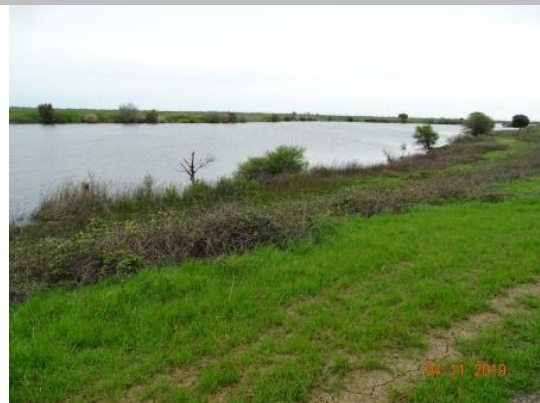
Photo 1 of 1 : SP_2019_RD0536_208_41_20190412_00060.jpg

LM Start	3.98	Rating **	M	Issue No.	41
LM End	3.98	Issue Type +	Ma	Location *	WS
Category	Earthen Levee			GPS Latitude/Longitude	
				Start	End
Item	Vegetation			38.250514 °	38.250514 °
				-121.722303 °	-121.722303 °
DWR ID	DWR_RD0536_01_s_2019_41				
Comment Code					
V2 : Remove the wild growth other than native grasses from the levee slopes.					
Inspector Comment					
Remove blackberries at least 20' from waterside shoulder.

View looking downstream at blackberries on the waterside slope (Spring 2019).

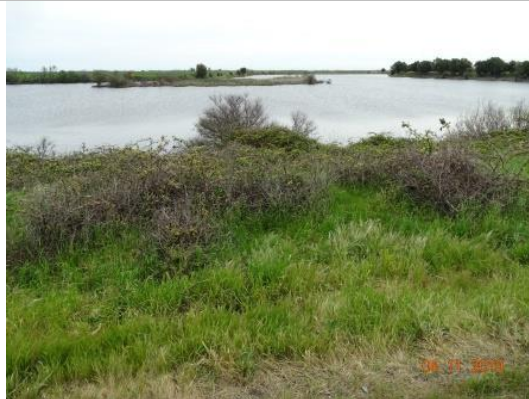
Photo 1 of 1 : SP_2019_RD0536_208_42_20190412_00061.jpg

View looking downslope at blackberries on the waterside slope (Spring 2019).

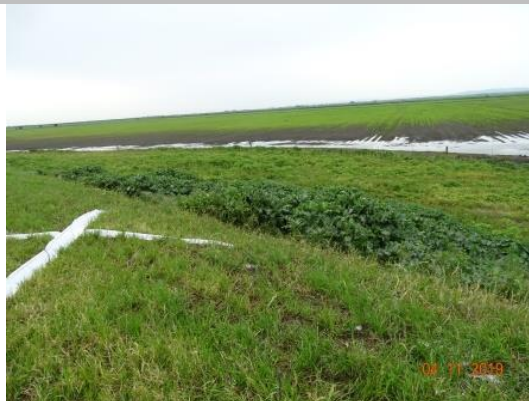
Photo 1 of 1 : SP_2019_RD0536_208_37_20190418_00064.jpg

LM Start	4.64	Rating **	M	Issue No.	37
LM End	5.18	Issue Type +	Ma	Location *	LS
Category	Earthen Levee			GPS Latitude/Longitude	
				Start	End
Item	Vegetation			38.248151 °	38.245234 °
				-121.711975 °	-121.704770 °
DWR ID	DWR_RD0536_01_s_2019_37				
Comment Code					
V2 : Remove the wild growth other than native grasses from the levee slopes.					
Inspector Comment					
Remove wild growth from the bottom of landside slope.

View looking downstream at wild growth on the bottom of the landside slope (Spring 2019).

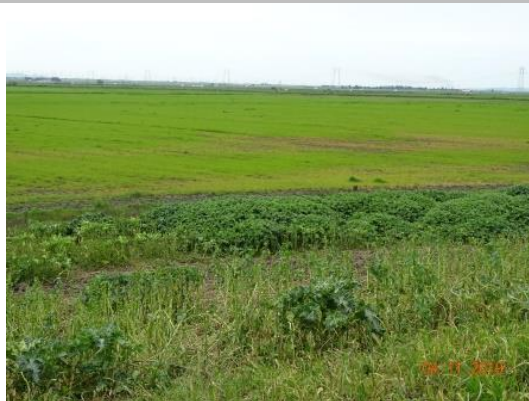
Photo 1 of 1 : SP_2019_RD0536_208_43_20190412_00062.jpg

View looking downslope at vegetation at the bottom of the landside (Spring 2019).

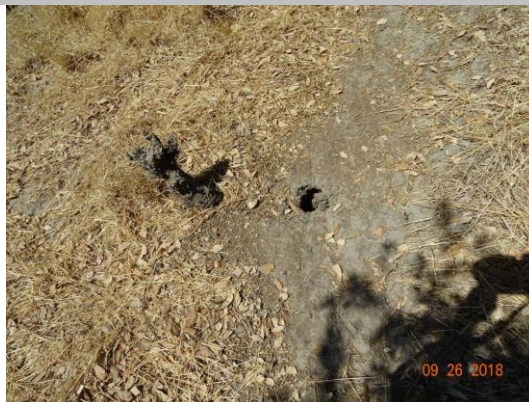
Photo 1 of 1 : SP_2019_RD0536_208_26_20190311_00017.jpg

View of squirrel hole on the landside slope (September 2018).

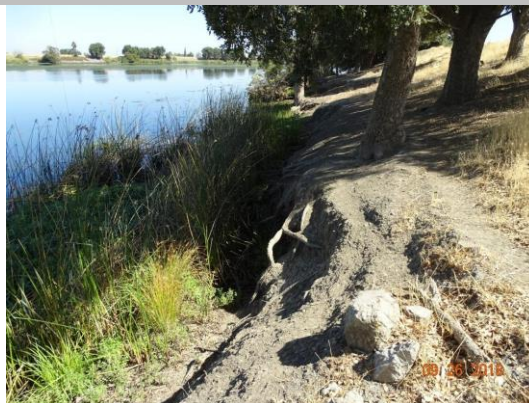
Photo 1 of 1 : SP_2019_RD0536_208_16_20190311_00004.jpg

LM Start	4.94	Rating **	M	Issue No.	16
LM End	4.95	Issue Type +	Ma	Location *	WS
Category	Supplemental			GPS Latitude/Longitude	
				Start	End
Item	2017 USACE Erosion Survey, DRAFT			38.245581 °	38.245667 °
				-121.708605 °	-121.708327 °
DWR ID	DWR_RD0536_01_f_2018_16				
Comment Code					
Inspector Comment					
2017 Site ID: LDS 0.8 R					
Status: Eroding					
2017 Field Notes: additional erosion at toe.					
Site History: 2011 - Multiple erosion pockets from tree popouts. A smaller erosion pocket in the middle of a failing bank repair. Pump structure at the downstream end may be contributing to the erosion.

Deeper erosion at the toe with roots exposed (September 2018).

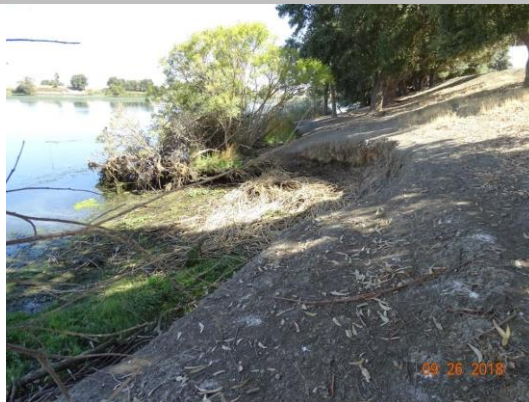
Photo 1 of 1 : SP_2019_RD0536_208_15_20190311_00003.jpg

Large erosion pocket on the waterside slope extends deep into slope (September 2018).

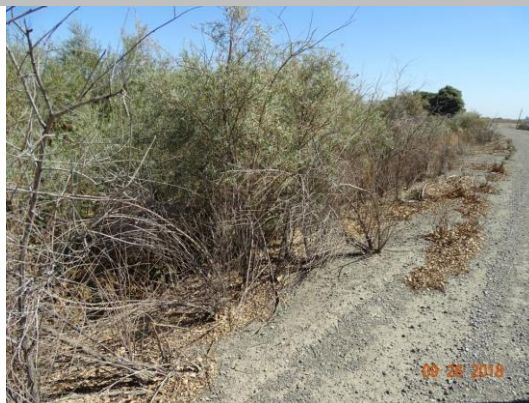
Photo 1 of 1 : SP_2019_RD0536_208_27_20190311_00018.jpg

View of vegetation on the waterside up to the crown that is blocking visibility (September 2018).

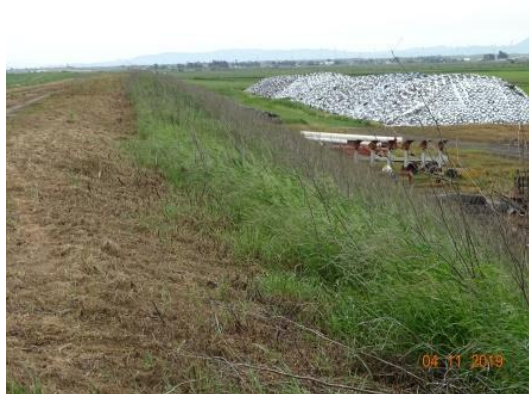
Photo 1 of 1 : SP_2019_RD0536_209_7_20190412_00020.jpg

View looking downstream at annual vegetation on the landside slope (Spring 2019).

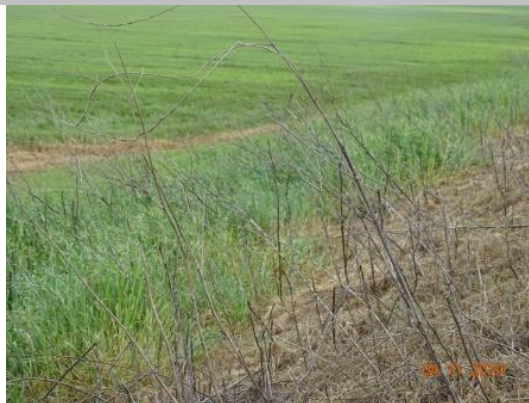
Photo 1 of 1 : SP_2019_RD0536_209_16_20190412_00021.jpg

View looking downstream at annual vegetation on the waterside slope (Spring 2019).

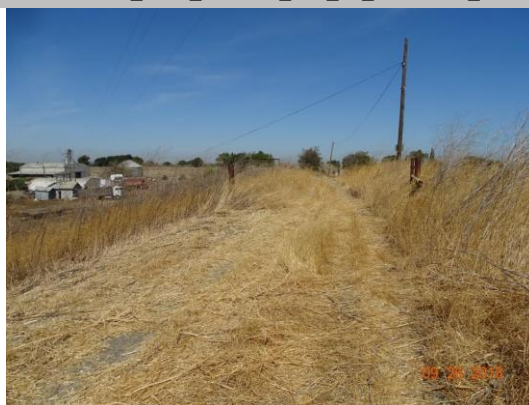
Photo 1 of 1 : SP_2019_RD0536_209_10_20190311_00004.jpg

View looking upstream at vegetation on the crown (September 2018).

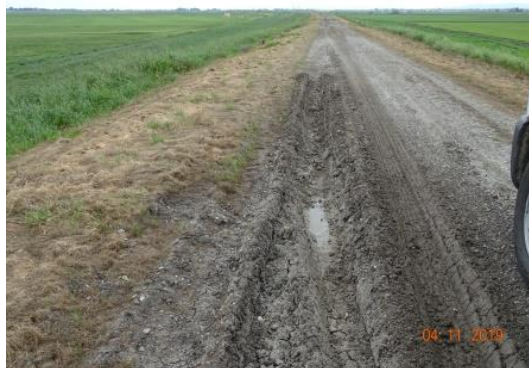
Photo 1 of 1 : SP_2019_RD0536_209_17_20190412_00022.jpg

LM Start	1.19	Rating **	U	Issue No.	17
LM End	1.19	Issue Type +	Ma	Location *	CR
Category	Earthen Levee			GPS Latitude/Longitude	
				Start	End
Item	Crown Surface / Depressions / Rutting			38.228329 °	38.228329 °
				-121.697716 °	-121.697716 °
DWR ID	DWR_RD0536_02_s_2019_17				
Comment Code					
C2 : Repair depressions or ruts in the crown or slope.					
Inspector Comment

View looking downstream at deep rut on the crown (Spring 2019).

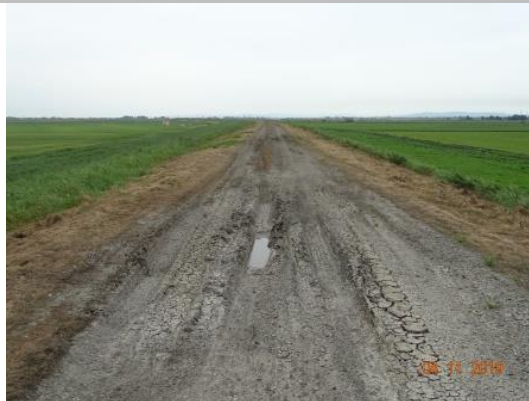
Photo 1 of 1 : SP_2019_RD0536_209_18_20190412_00023.jpg

LM Start	1.24	Rating **	U	Issue No.	18
LM End	1.24	Issue Type +	Ma	Location *	CR
Category	Earthen Levee			GPS Latitude/Longitude	
				Start	End
Item	Crown Surface / Depressions / Rutting			38.227689 °	38.227689 °
				-121.697644 °	-121.697644 °
DWR ID	DWR_RD0536_02_s_2019_18				
Comment Code					
C2 : Repair depressions or ruts in the crown or slope.					
Inspector Comment

View looking downstream at deep rut on the crown (Spring 2019).

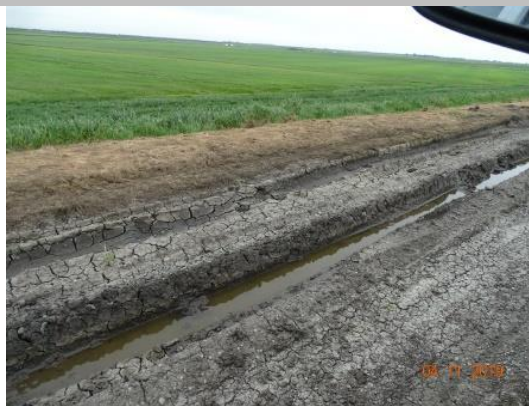
Photo 1 of 1 : SP_2019_RD0536_209_19_20190412_00024.jpg

LM Start	1.35	Rating **	U	Issue No.	19
LM End	1.35	Issue Type +	Ma	Location *	CR
Category	Earthen Levee			GPS Latitude/Longitude	
				Start	End
Item	Crown Surface / Depressions / Rutting			38.226011 °	38.226011 °
				-121.697401 °	-121.697401 °
DWR ID	DWR_RD0536_02_s_2019_19				
Comment Code					
C2 : Repair depressions or ruts in the crown or slope.					
Inspector Comment

View looking slightly downstream at deep rut on the crown (Spring 2019).

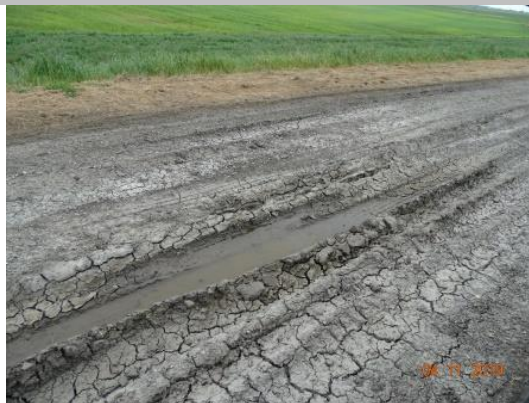
Photo 1 of 1 : SP_2019_RD0536_209_20_20190412_00025.jpg

View looking slightly downstream at deep rut on the crown (Spring 2019).

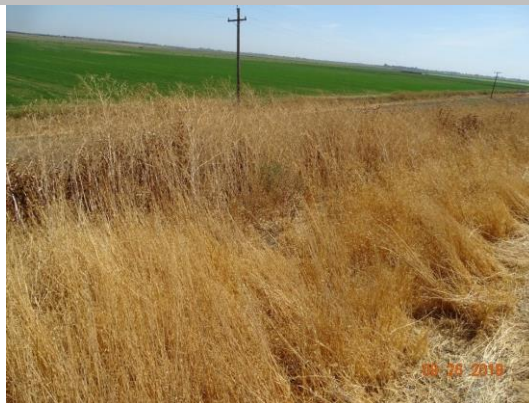
Photo 1 of 1 : SP_2019_RD0536_209_13_20190311_00007.jpg

View looking slightly downstream at thick vegetation all the way up to the crown (September 2018).

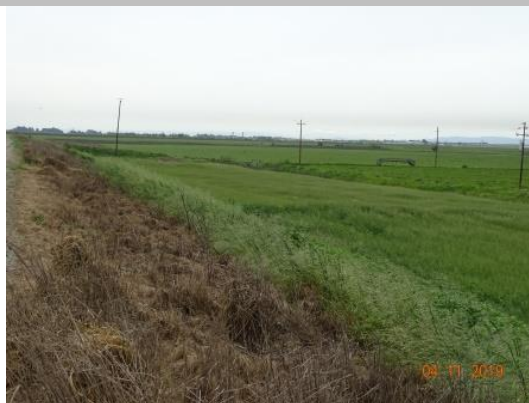
Photo 1 of 1 : SP_2019_RD0536_209_21_20190412_00026.jpg

View looking downstream at annual vegetation on the landside slope (Spring 2019).

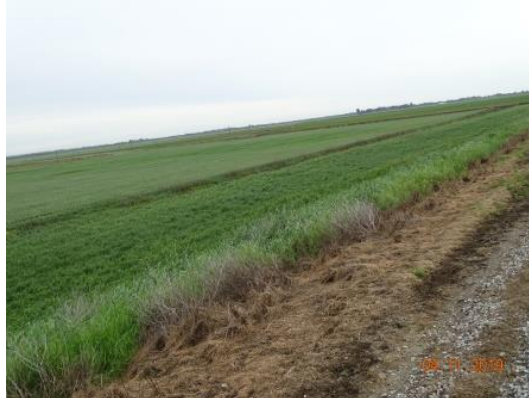
Photo 1 of 1 : SP_2019_RD0536_209_23_20190412_00027.jpg

View looking downstream at annual vegetation on the waterside slope (Spring 2019).
